## **Report #235**

## Red River Coal Company Benthic Macroinvertebrate Survey Spring 2014 SFP-1

Biological Monitoring, Inc. (BMI) performed a stream survey in the South Fork Pound River Watershed for Red River Coal Company. The purpose of this survey was to conduct instream assessments as outlined in Red River's permits. One instream monitoring station was sampled.

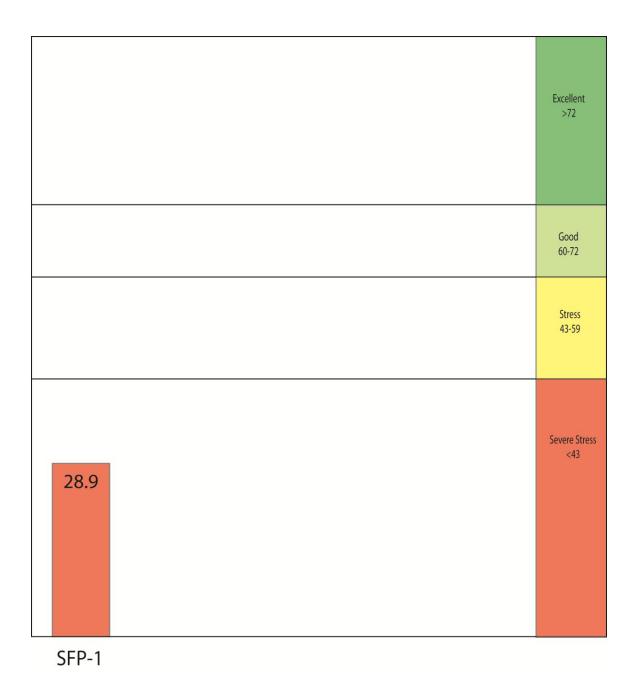
Figure 3. VASCI Scoring Summary

Table 6 presents a summary of the VASCI scoring. Raw data are presented in Appendix B. Each metric score represents a percentage of the statewide reference condition. The VASCI score calculated for SFP-1 was 28.86.

Figure 3 is a graphical representation of the VASCI score(s) along with the Aquatic Life Use Tiers. It should be noted that four tiers exist in the VASCI, whereas, a score of 60 or higher is considered "unimpaired" and a score of < 60 is considered "impaired".

The VASCI score calculated was 28.9 for station SFP-1. This score falls into the "Severe Stress" Aquatic Life Use tier.

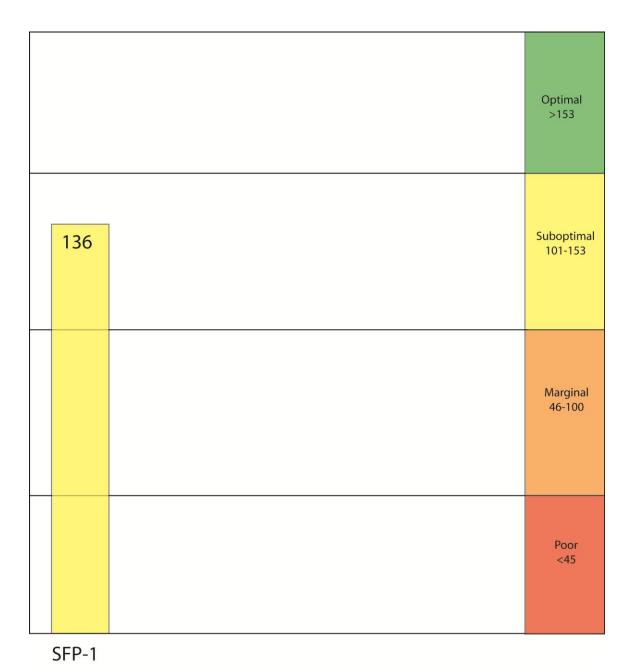
Figure 4. Habitat Scoring Sumary

Table 7 presents a summary of the habitat assessment score for the monitoring stations. Raw data are presented in Appendix B. The habitat assessment score was 136 for SFP-1 falling into the "Suboptimal" category of habitat.

Figure 4 is a visual representation of the habitat score(s) obtained for this permit along with the different tiers.

Habitat plays an important role in species composition, various assemblages and numbers of organisms found in aquatic environments. To make meaningful impact analyses, one must consider habitat data as a possible limiting factor. The habitat assessment score was 136 for station SFP-1 falling into the "Suboptimal" category of habitat.

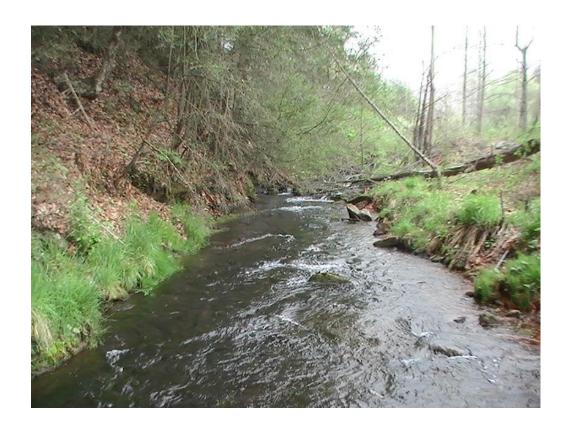
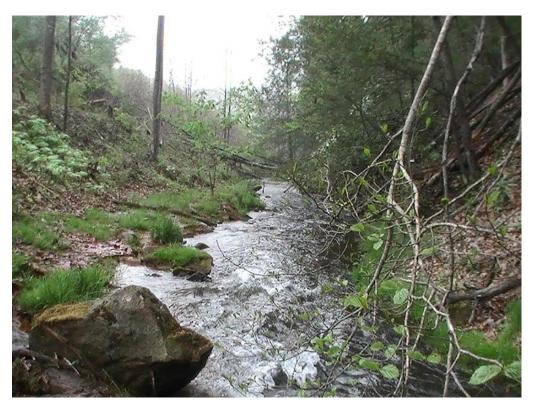
## SFP-1

Station attributes, including latitudes and longitudes are presented in Table 1 and depicted in Figures 1 and 2. Station photographs are presented in Appendix A. Flow was adequate for sampling at all stations.
